1N-23
3802
NASA Contractor Report 4586

Analysis of Selected Materials Flown on Interior Locations of the Long Duration Exposure Facility

H. A. Smith, K. M. Nelson, D. Eash, and H. G. Pippin

Contracts NAS1-18224 and NAS1-19247
Prepared for Langley Research Center

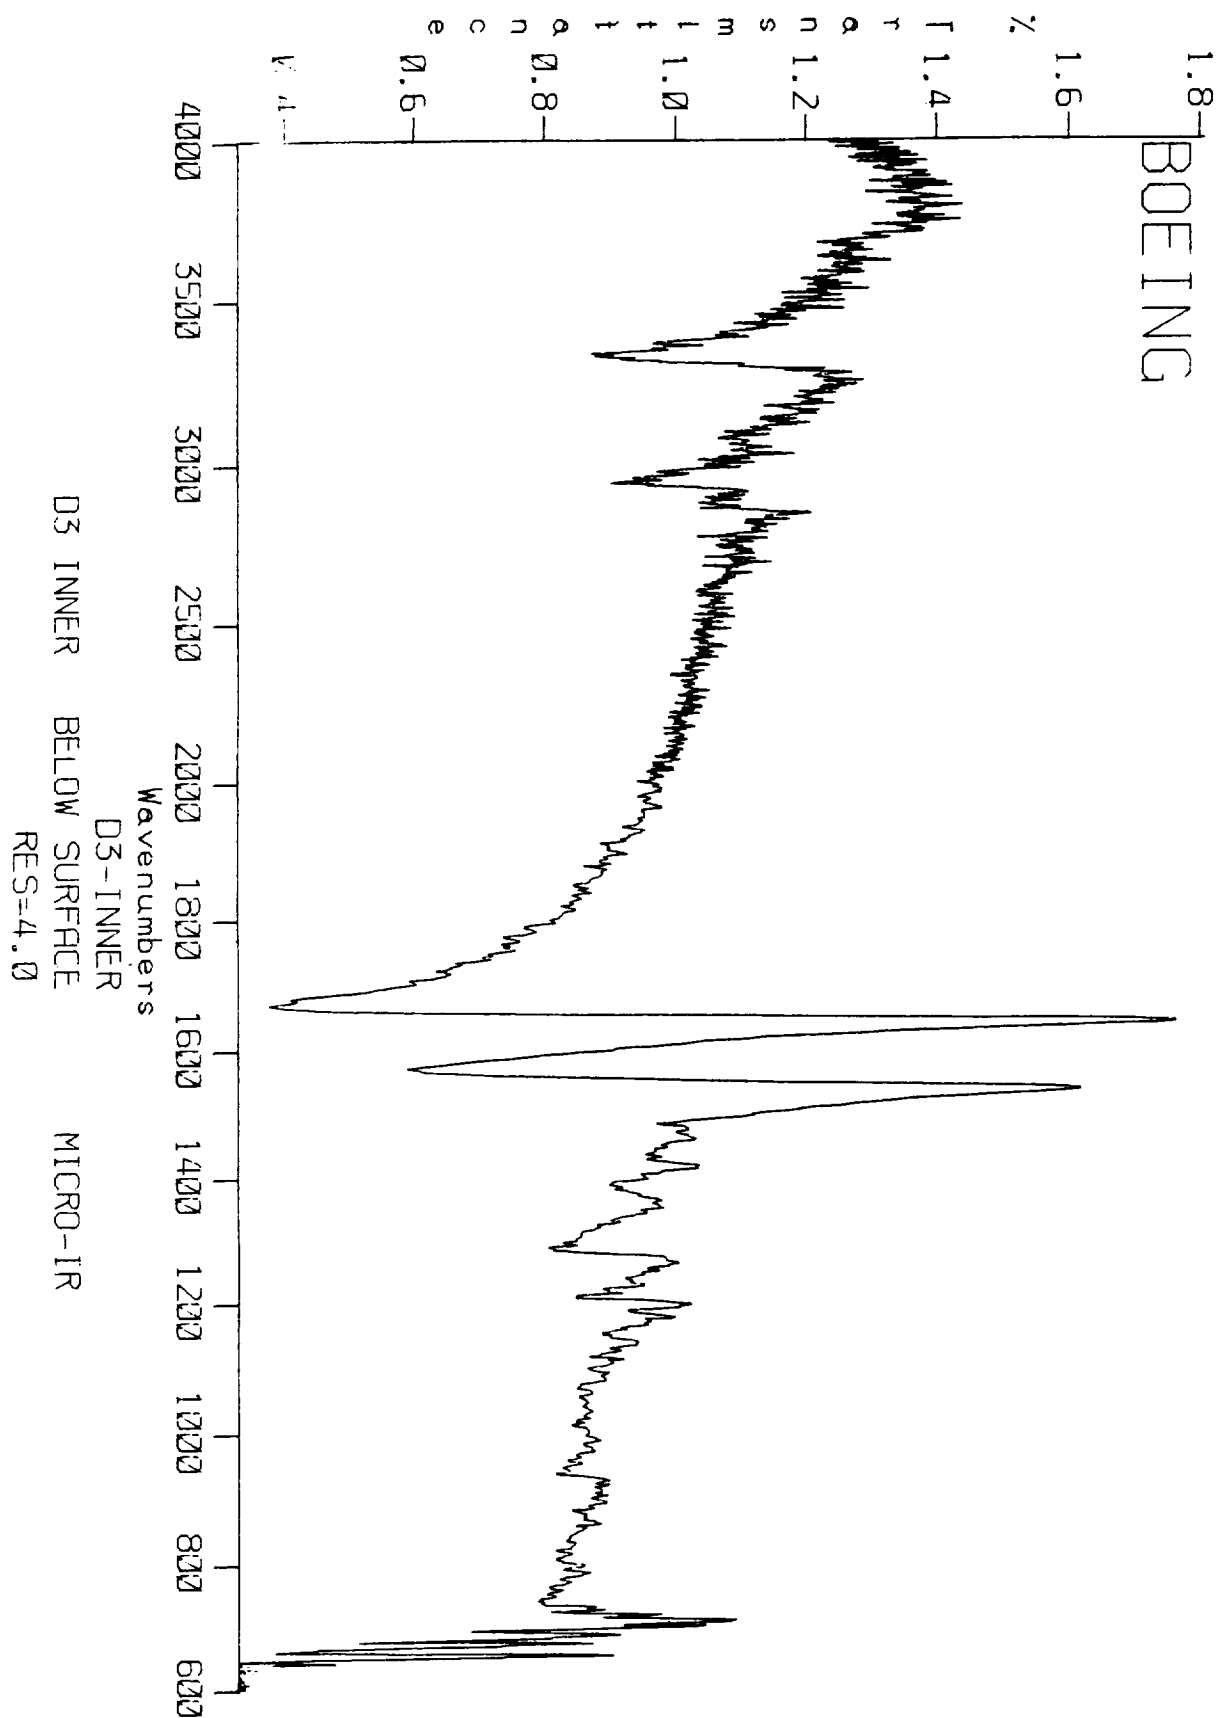
Figure 24. IR transmission spectrum of bulk material from wire harness bundle nylon grommet D3.

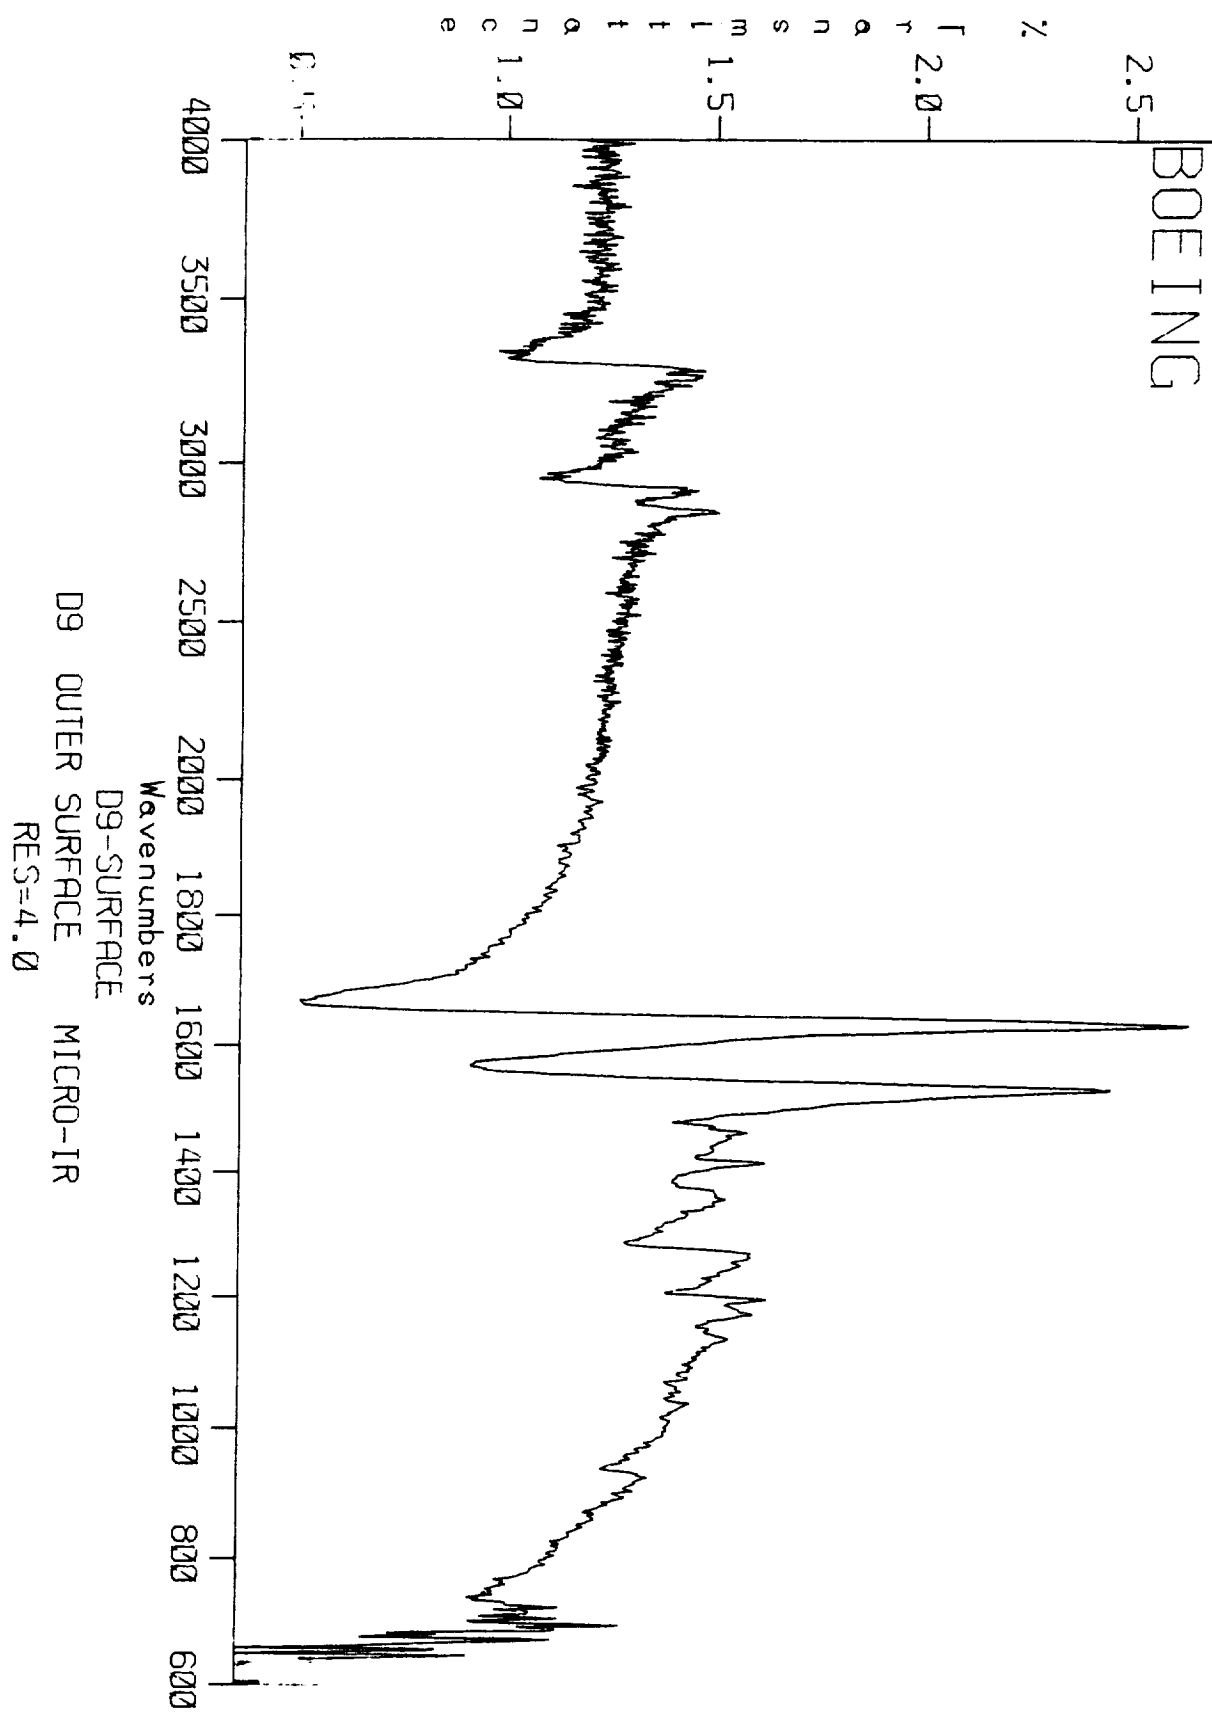
Figure 25. IR transmission spectrum of surface of wire harness bundle nylon grommet D9.

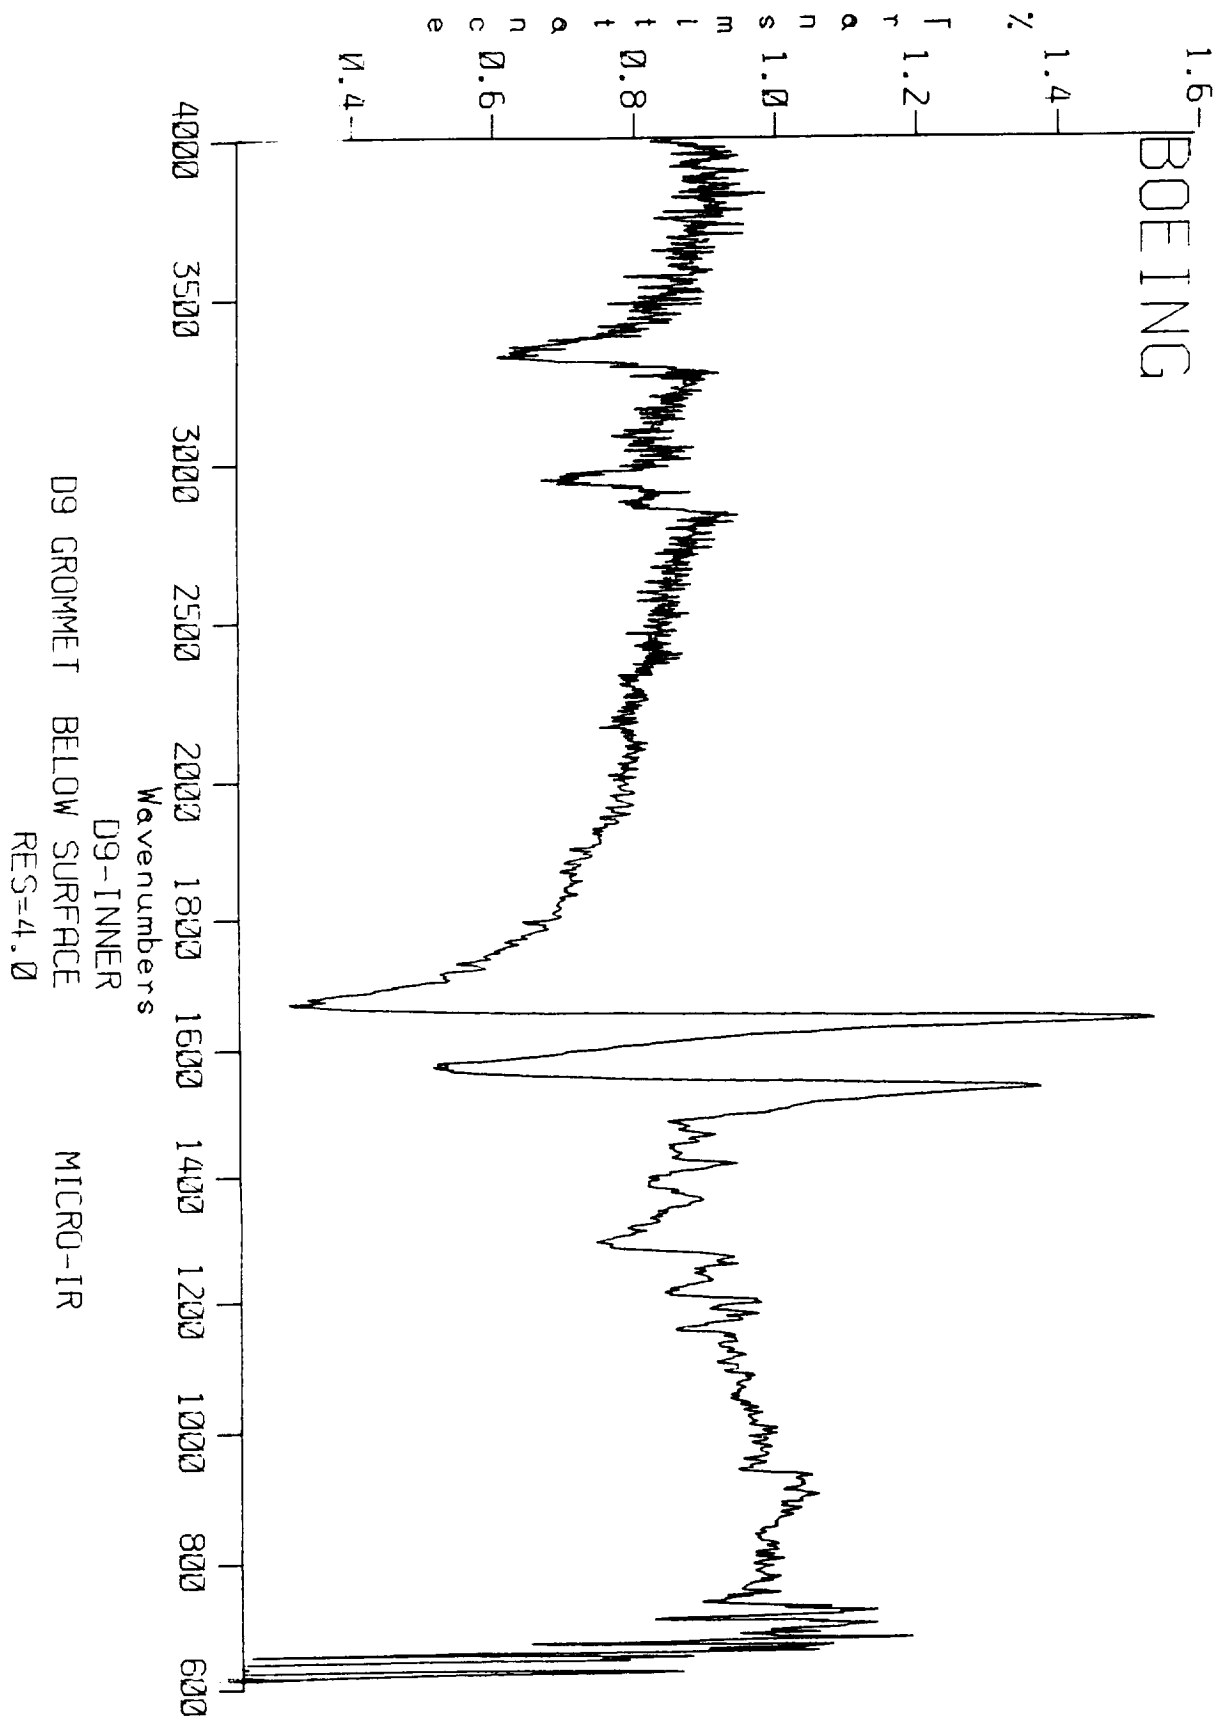
Figure 26. IR transmission spectrum of bulk material from wire harness bundle nylon grommet D9.

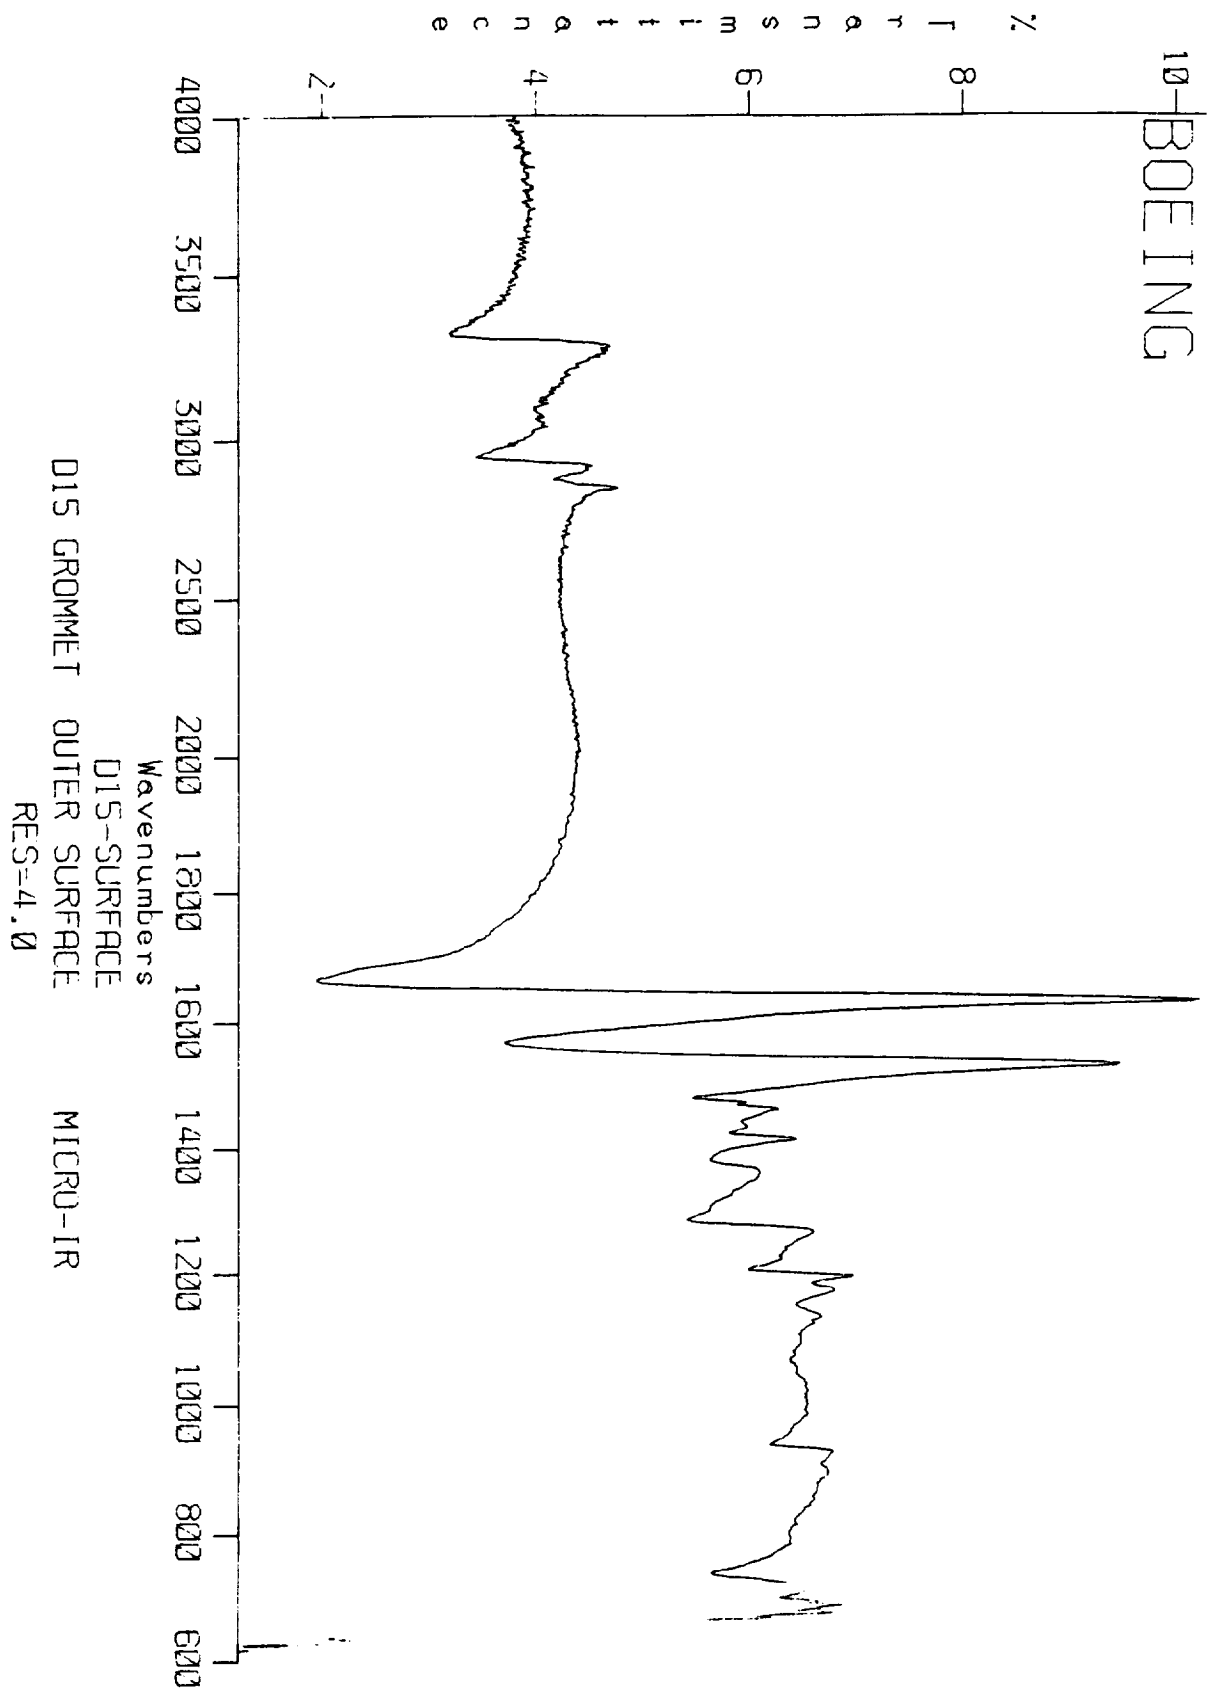
Figure 27. IR transmission spectrum of surface of wire harness bundle nylon grommet D15.

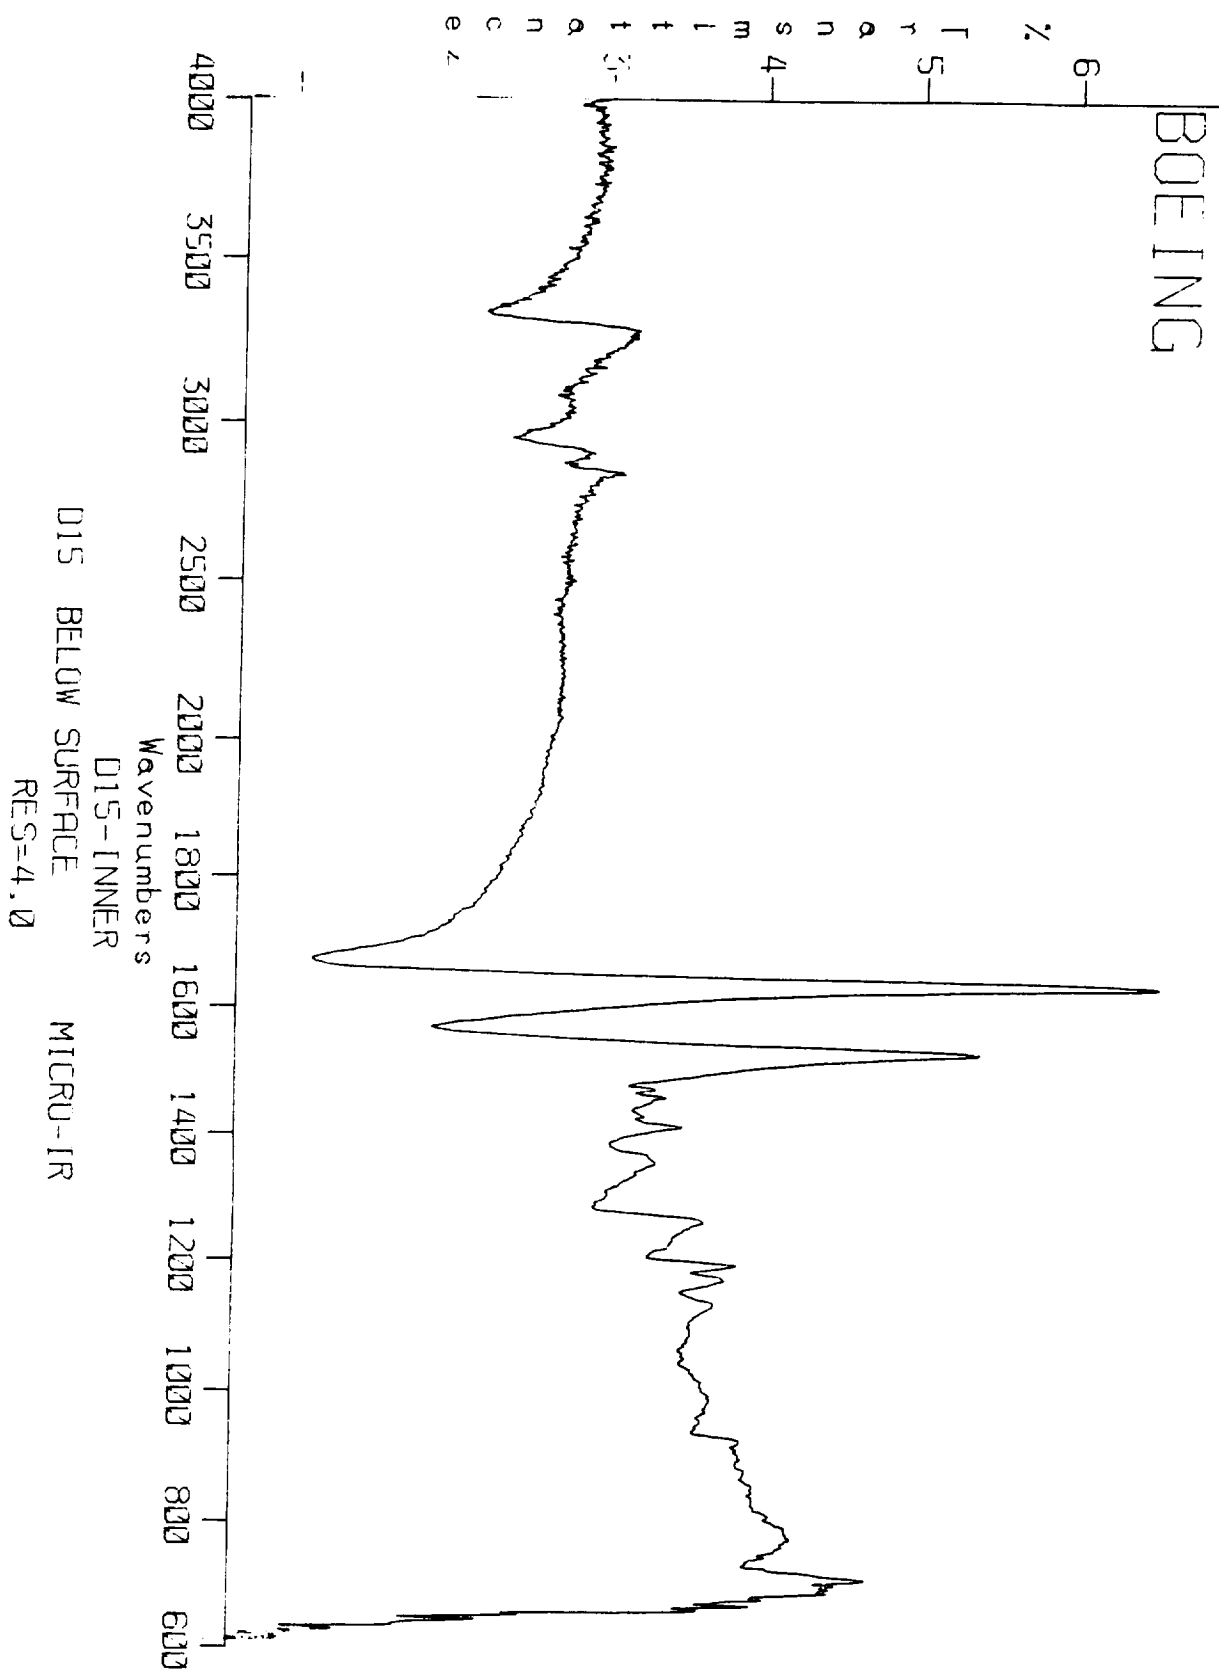
Figure 28. IR transmission spectrum of bulk material from wire harness bundle nylon grommet D15.

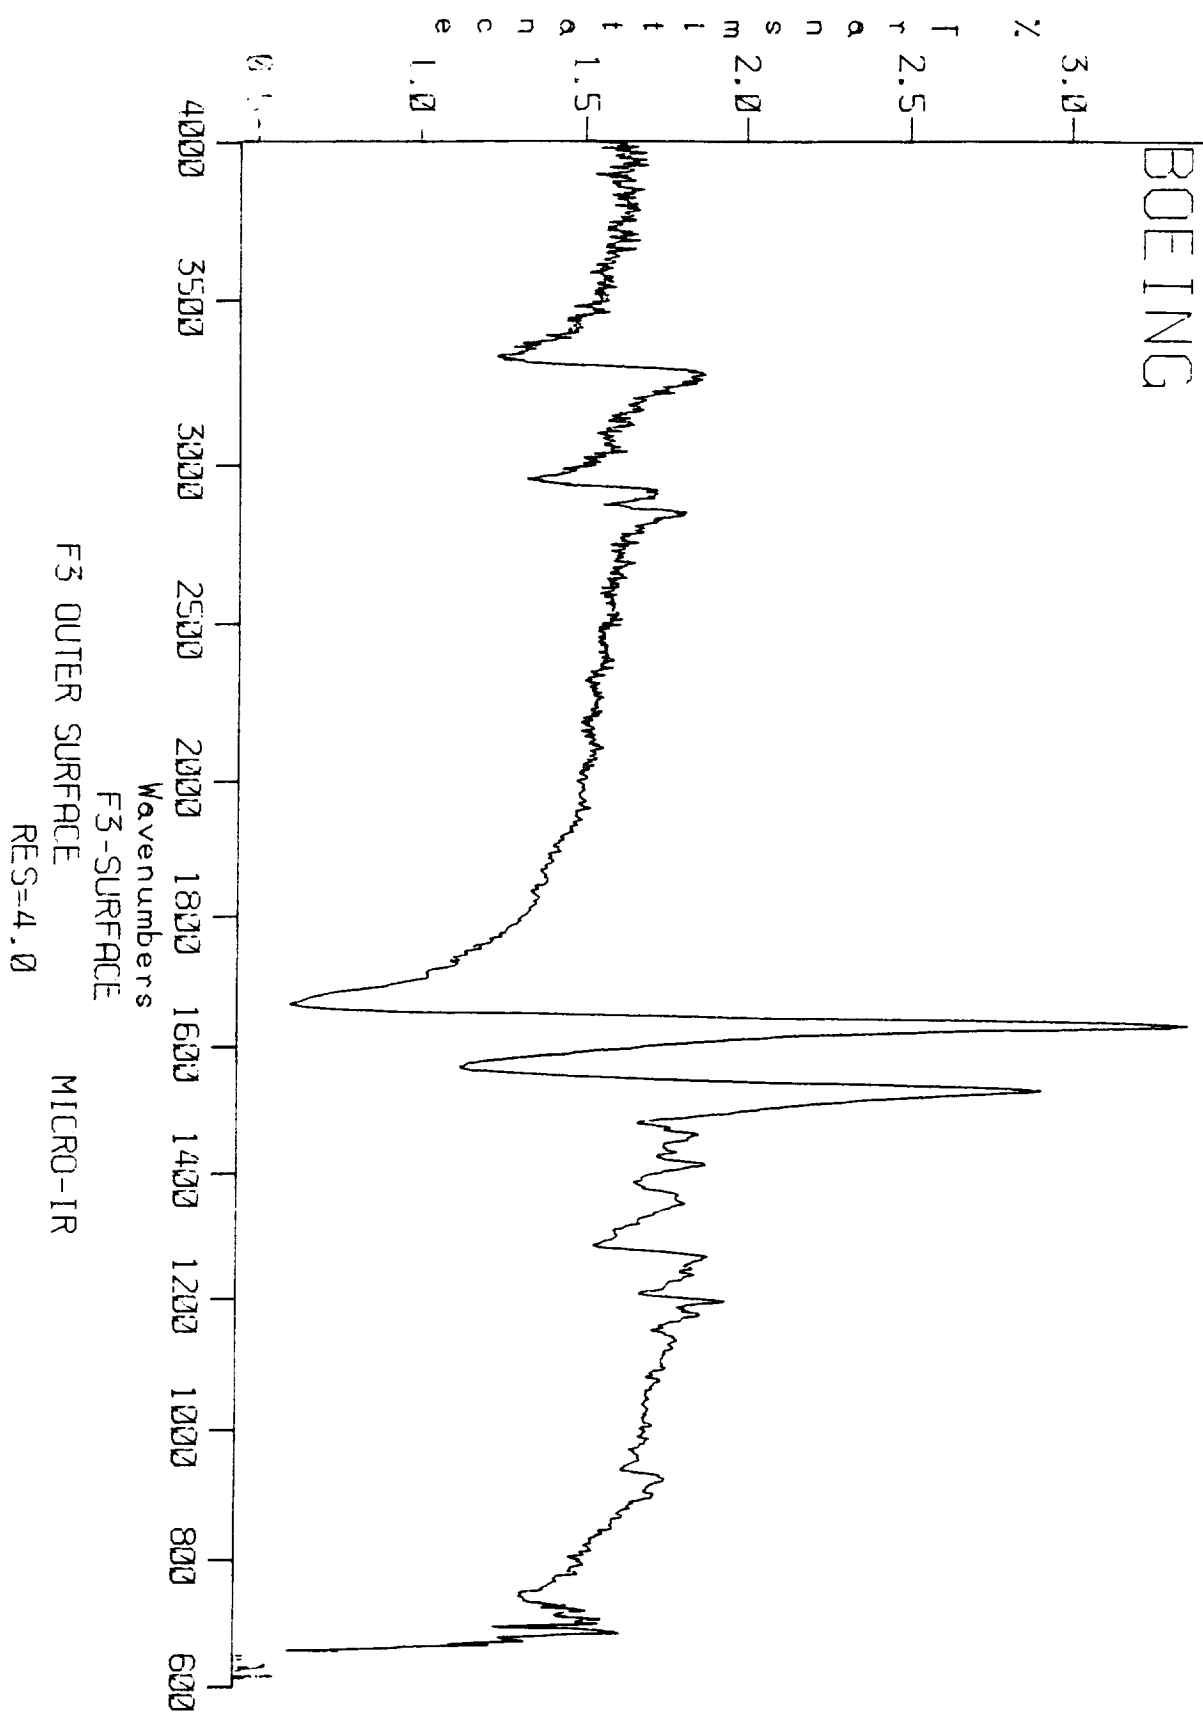
Figure 29. IR transmission spectrum of surface of wire harness bundle nylon grommet F3.

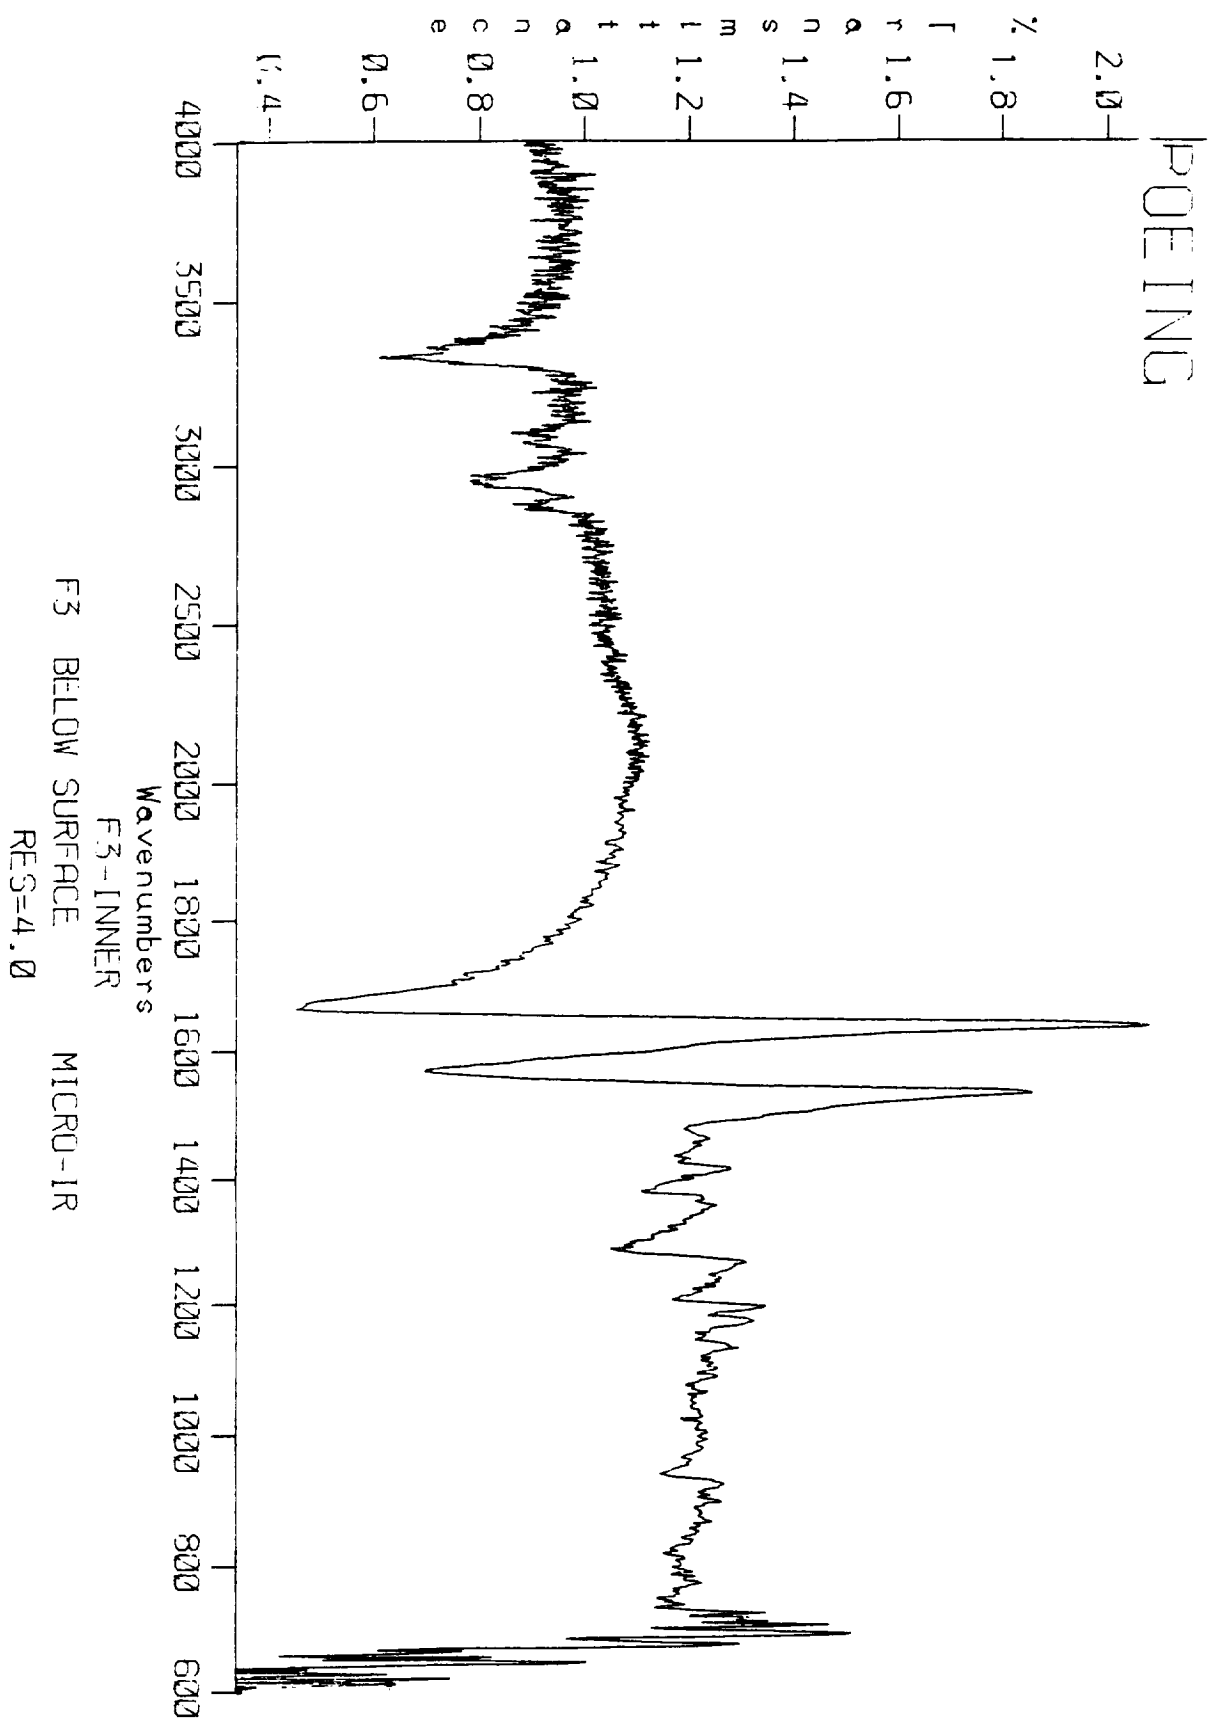
Figure 30. IR transmission spectrum of bulk material from wire harness bundle nylon grommet F3.

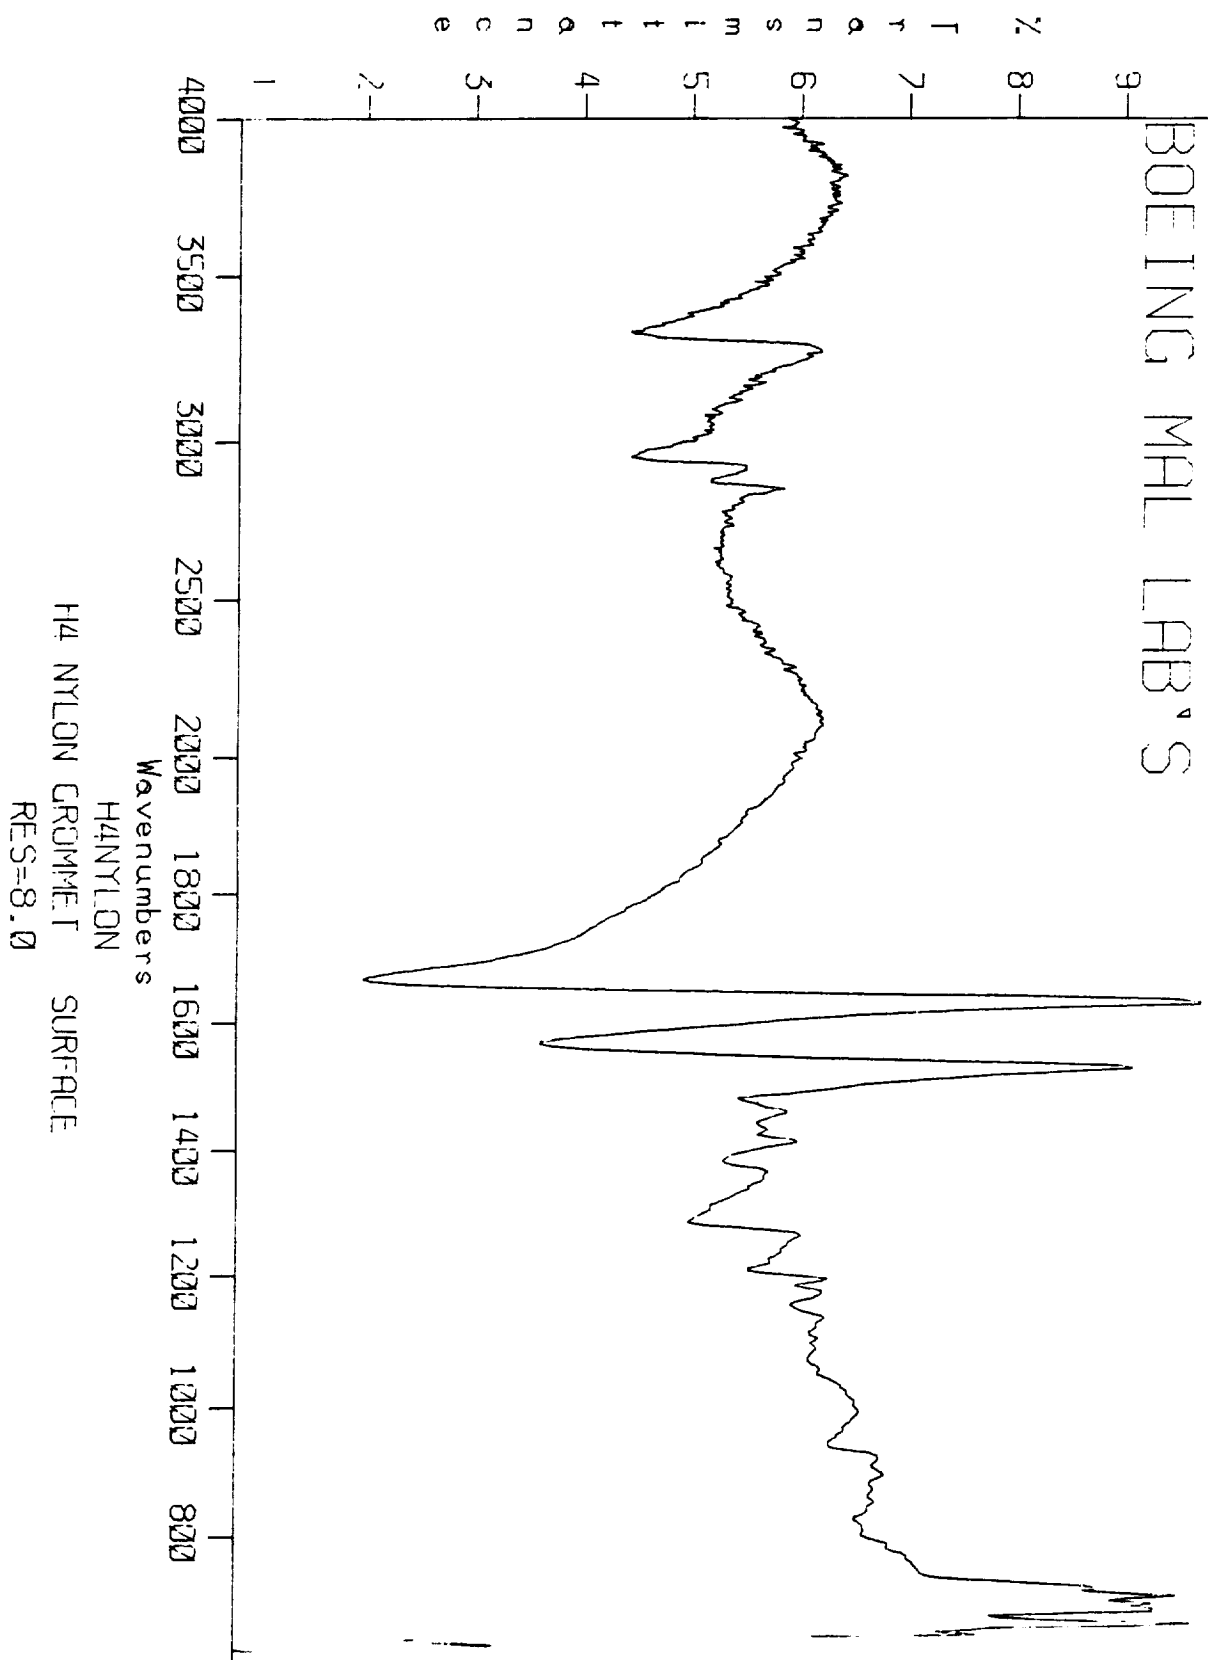
Figure 31. IR transmission spectrum of surface of wire harness bundle nylon grommet H4.

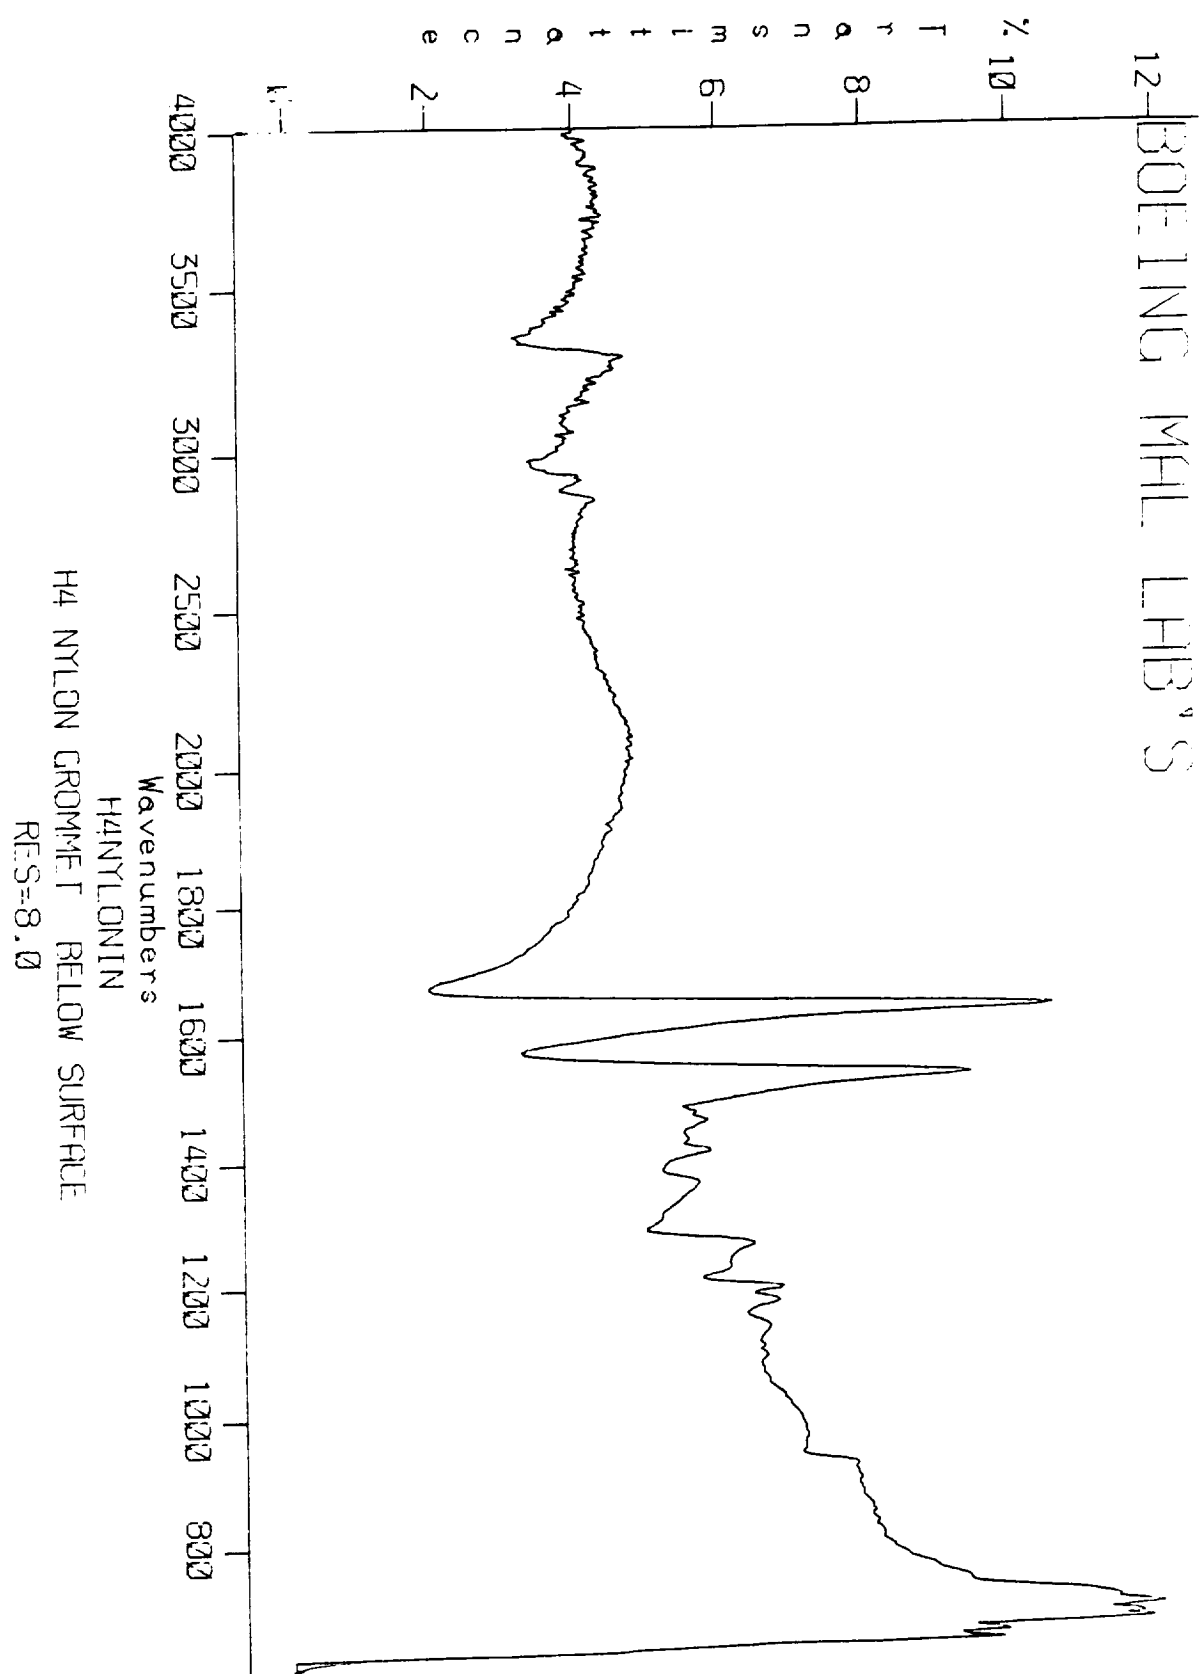
Figure 32. IR transmission spectrum of bulk material from wire harness bundle nylon grommet H4.

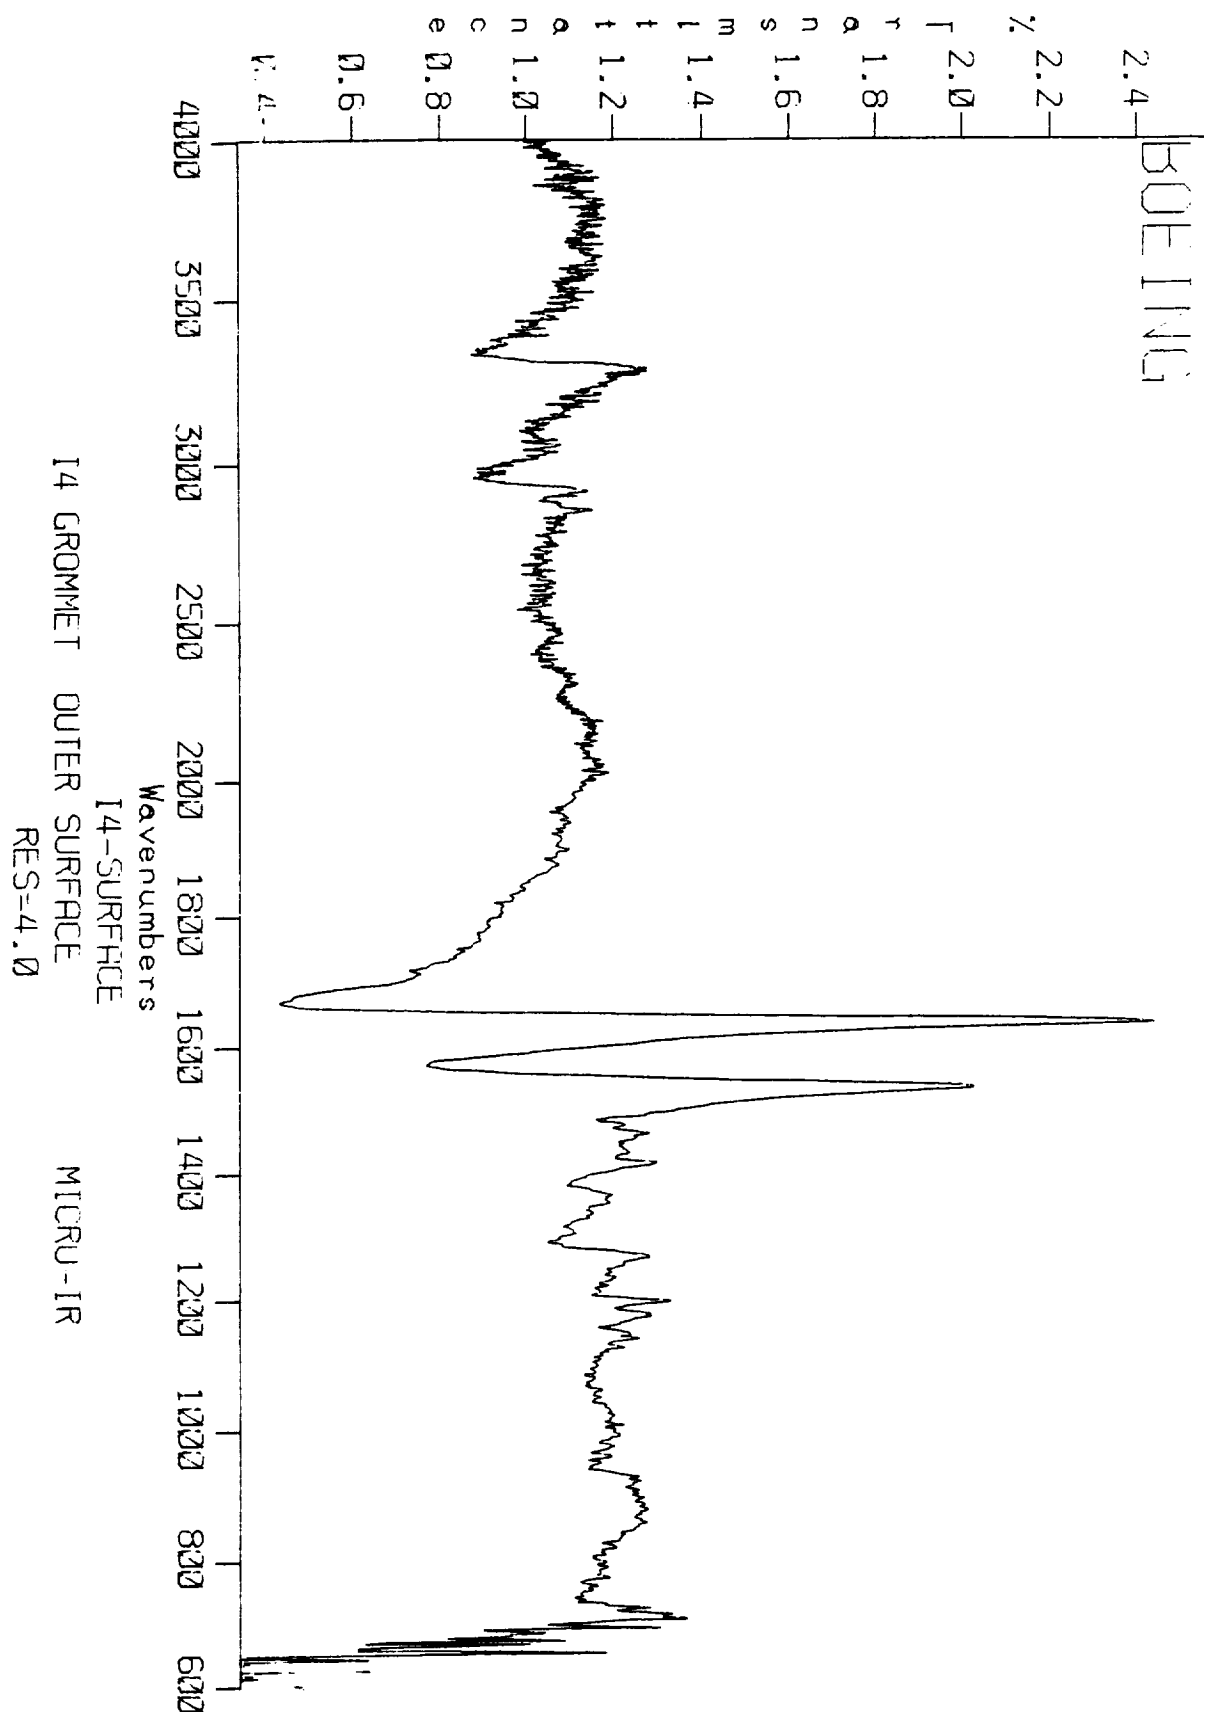
Figure 35. IR transmission spectrum of surface of wire harness bundle nylon grommet I4.

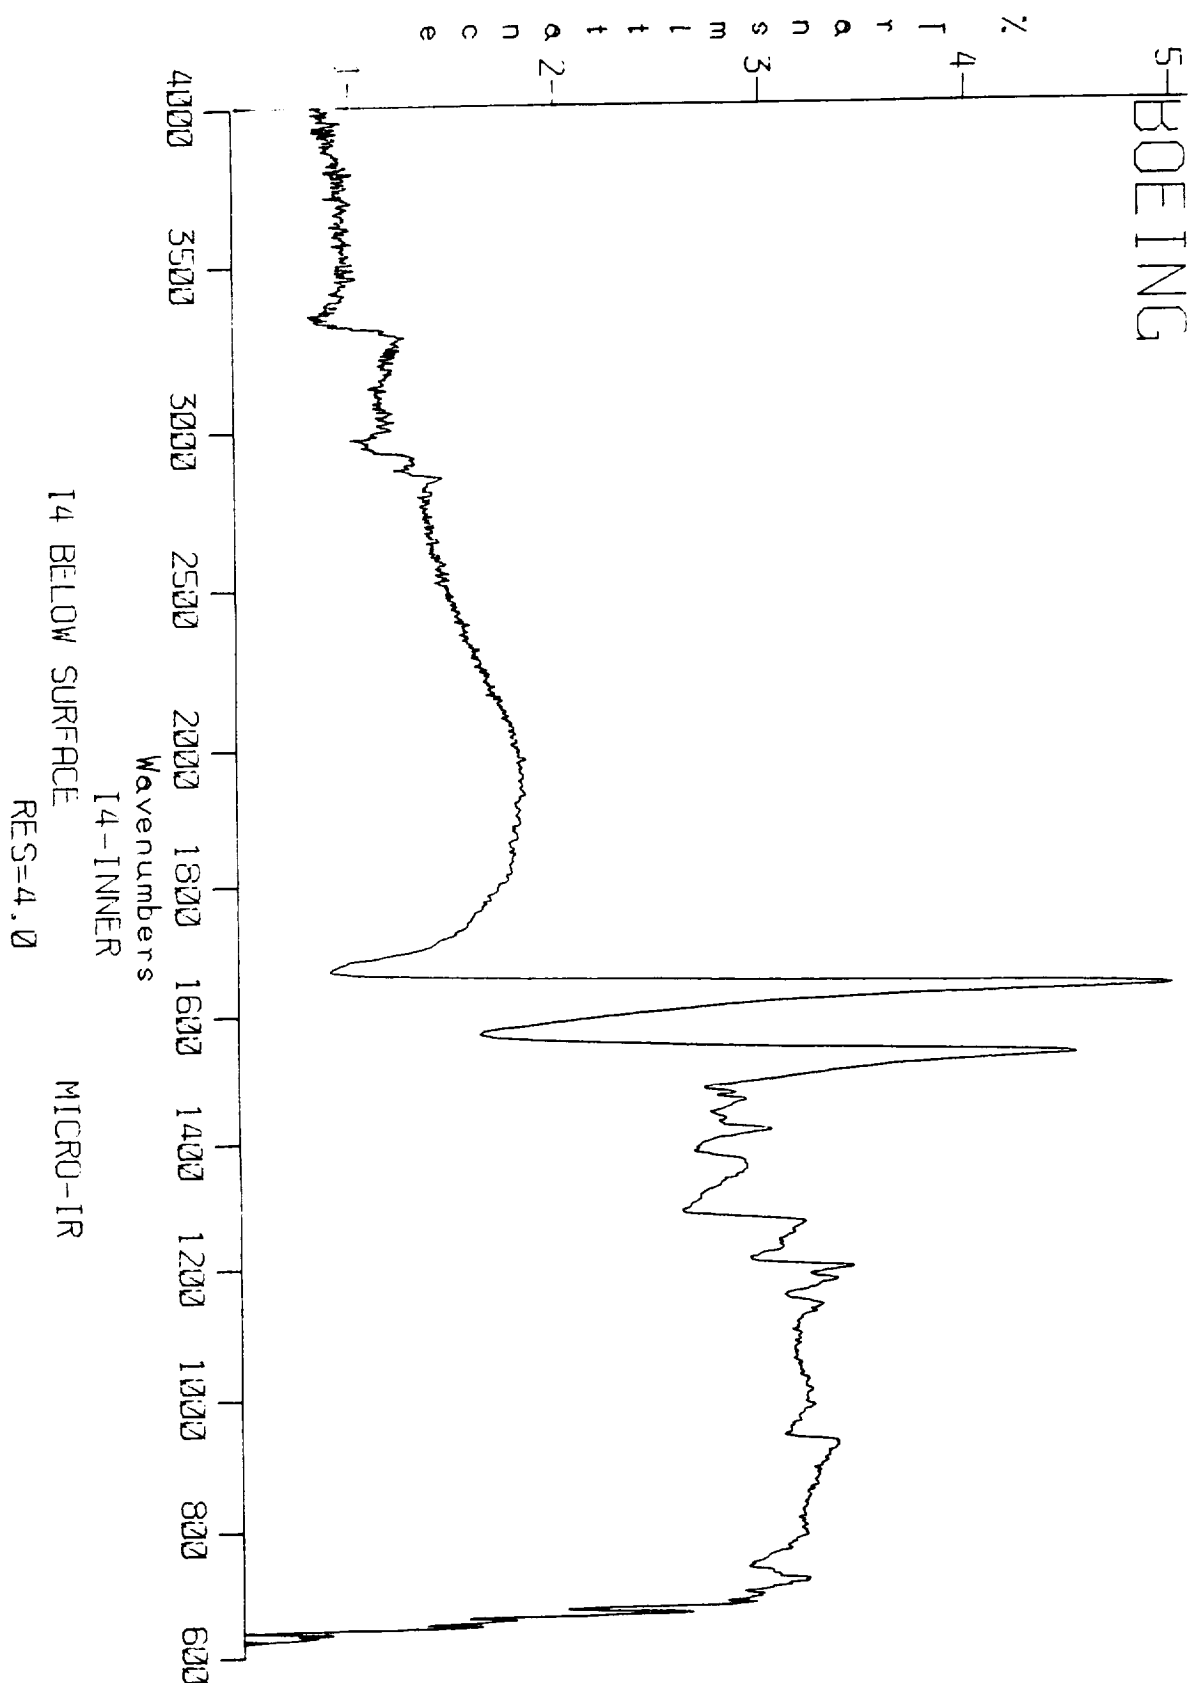
Figure 36. IR transmission spectrum of bulk material from wire harness bundle nylon grommet I4.
